TEST REPORT

Report No. : HL30175H/2004

Type of Product: Bracket
Style/Item No.: # 09A
Manufacture/Vendor: SUPER SHENG ENTERPRISE CO., LTD.
Country of Origin: Taiwan

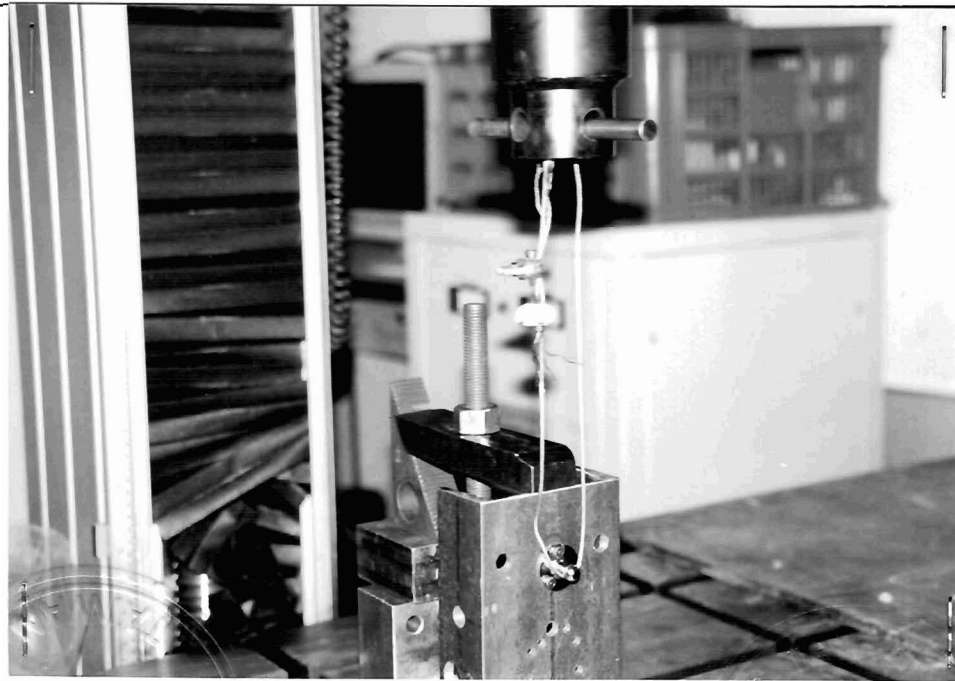
(B)

Secure the sample on the tensile machine (INSTRON 5581). Apply an increasing force to the sample until it is slid or broken then record the broken load and failure mode.
 (Speed: 5 mm/min.)

Photo Index:
 Photo "A": Sample picture. (See sample card page 1 of 1)
 Photo "B": Test methods. (See sample card page 1 of 1)
 Photo "C": Failure mode. (See sample card page 1 of 1)

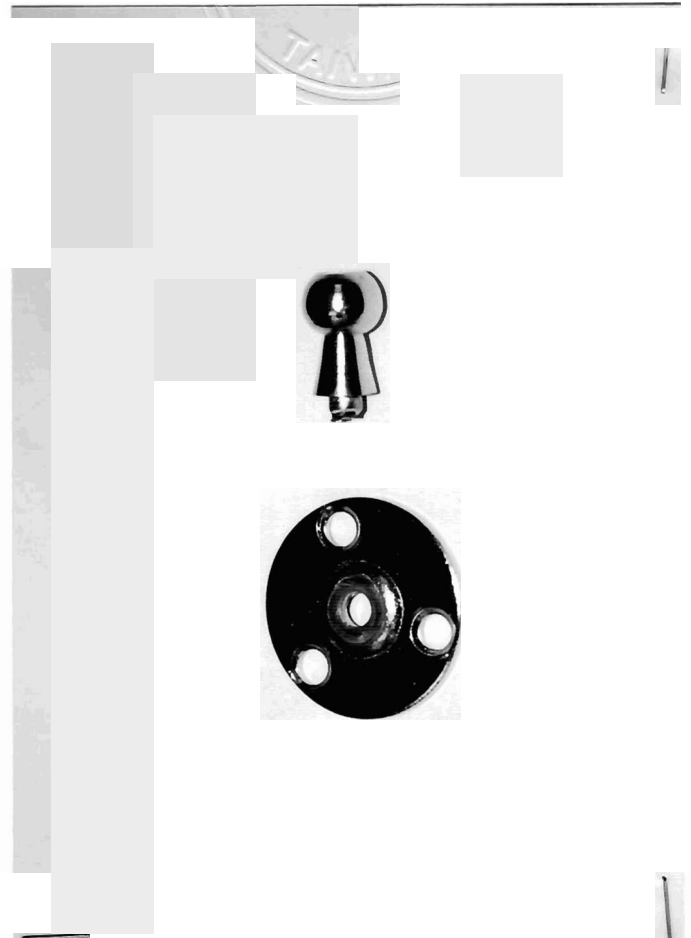
(C)

Sample	Max. load (kgf)	Failure mode
Bracket-# 09A	180.92	The ball stud was separated from the bracket.
