Report No. :
 HL10238A/2016

SUPER SHENG ENTERPRISE CO., LTD.

Product Description:	Bracket For Gas Spring	
Style/Item No.:	BKT-10-I/O, BKT-11, BKT-11A, BKT-B11, BKT-12, BKT-12A, BKT-B12,	
	BKT-21-I/O	
Manufacturer/Vendor:	SUPER SHENG ENTERPRISE CO., LTD.	
Country of Origin:	Taiwan	
Additional information:	Bolt Stud Material: Carbon Steel; Plate Material: P-O

We have tested the sub	omitted sample(s) as requested and the following results were obtained:
Test Requested:	Pulling test
Test Methods:	1. Fix the sample on the platform and hook a steel cable on the outer edge of protruding shaft.
	2. Apply an upward loading force in the axis of the protruding shaft by means of
	testing machine, until it is damaged then record the max. force.
	3. Testing Machine: INSTRON 5581; Speed: 10 mm/min.
	4. Diameter of steel cable: Ø 3.0 mm
Test Results:	See following sheet(s)
Date of Receipt:	Jan. 18, 2016
Testing Period:	Jan. 18, 2016 ~ Jan. 30, 2016

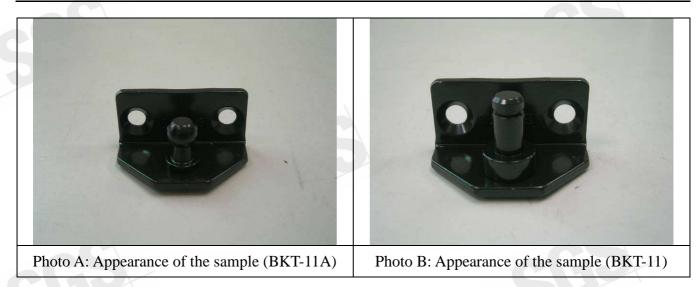
- Picture(s) -

est Results:		
Sample	Max. force (kgf)	Result
BKT-11A	422.5	The sample was damaged after testing. (As shown in photo I)
BKT-11	196.0	The sample was damaged after testing. (As shown in photo J)
BKT-B11	290.6	The sample was damaged after testing. (As shown in photo K)
BKT-10-I/O	310.6	The sample was damaged after testing. (As shown in photo L)
BKT-21-I/O	308.2	The sample was damaged after testing. (As shown in photo M)
BKT-12	195.7	The sample was damaged after testing. (As shown in photo N)
BKT-12A	448.2	The sample was damaged after testing. (As shown in photo O)
BKT-B12	468.4	The sample was damaged after testing. (As shown in photo P)
